Smoke and Dye Testing Summary

High Level Sewershed

Run Summary

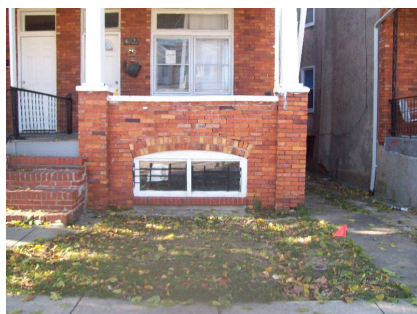
Picture \S1028-148-OB01-P01.jpg

Source Cleanout

Location Yard - front

Comments Smoke from cleanout in front yard. 4822 Palmer Ave.

Comments Front of house, 4822 Palmer Ave.

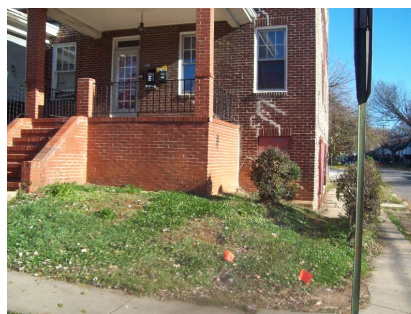
Picture \S1028-148-OB02-P01.jpg

Source Service Lateral

Location Yard - front

Comments Smoke from service lateral in front yard 3 ft. from cleanout. 4901 Palmer Ave.

Comments Smoke indicated by flag on the right. Front of house 4901 Palmer Ave.

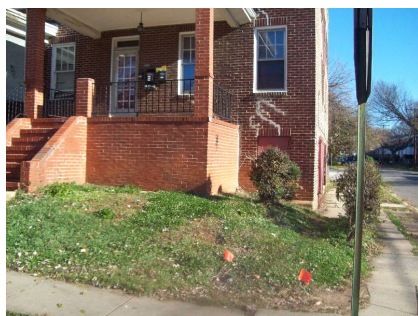
Picture \S1028-148-OB03-P01.jpg

Source Service Lateral

Location Yard - front

Comments Smoke from service lateral in front yard 1 ft. from cleanout. 4901 Palmer Ave.

Comments Smoke indicated by flag on the left. Front of house, 4901 Palmer Ave.
